DEPARTMENT BULLETIN NO. 1232

DAMAGE BY TERMITES IN THE CANAL ZONE AND PANAMA AND HOW TO PREVENT IT.

By THOMAS E. SNYDER, *Entomologist, Forest Insect Investigations*, and JAMES ZETEK, *Specialist in Tropical Entomology, Bureau of Entomology*.¹

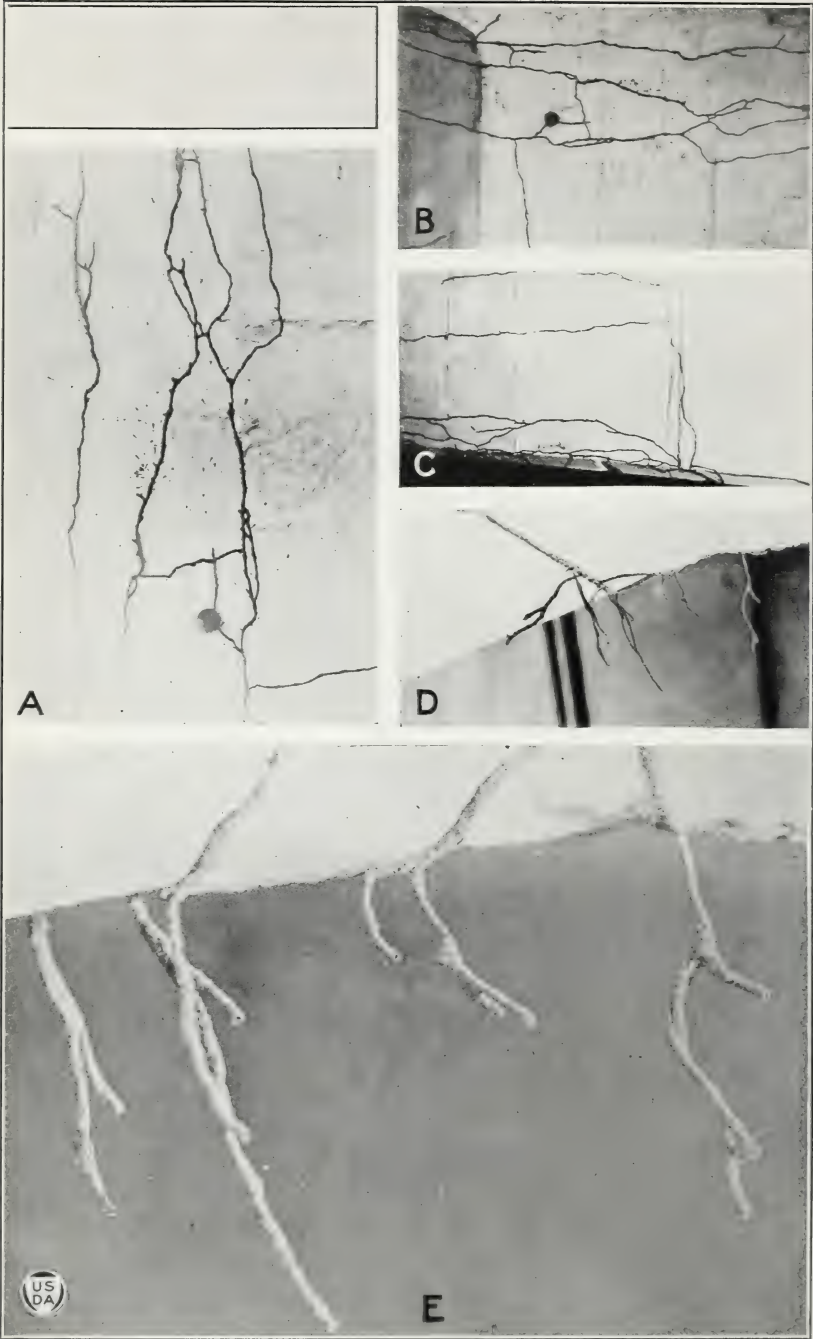
DAMAGE BY KALOTERMITDAEI TO THE DRY HARD WOOD OF FURNITURE IN BUILDINGS.

Zetek found soldiers and deälated sexual adults in hard beech wood of a drawer of a desk in Section B of Ancon Hospital on August 30, 1921. The desk had been in this screened concrete building for five years (Pl. III, *A*).

The dry hardwood of a back panel of an organ in the Roman Catholic Chapel at Ancon, Canal Zone, was found by Zetek, on October 19, 1921, to be damaged by this termite. The insects had gone into nearly all parts of the wood (Pl. III, *B*). No winged forms were present and soldiers were very scarce; nymphs of the sexual adults were abundant. Out of the back of this organ as much as 500 cubic centimeters of impressed pellets of excrement (Pl. III, *C*) could have been obtained; the actual size of these pellets is 0.85 by 0.54 millimeter.

A, Hard beech wood from a drawer of a desk damaged by *Cryptotermes thompsonae*, in a building at Ancon, C. Z. B, Back panel of an organ in a chapel at Ancon, damaged by *C. thompsonae*. C, Pellets of *C. thompsonae* near natural size. D, Wood from poplar case damaged by *C. thompsonae* in a building at Ancon, C. Z. E, Impressed pellets of excrement of *C. thompsonae*, greatly enlarged; actual size, 0.85 by 0.54 millimeter.

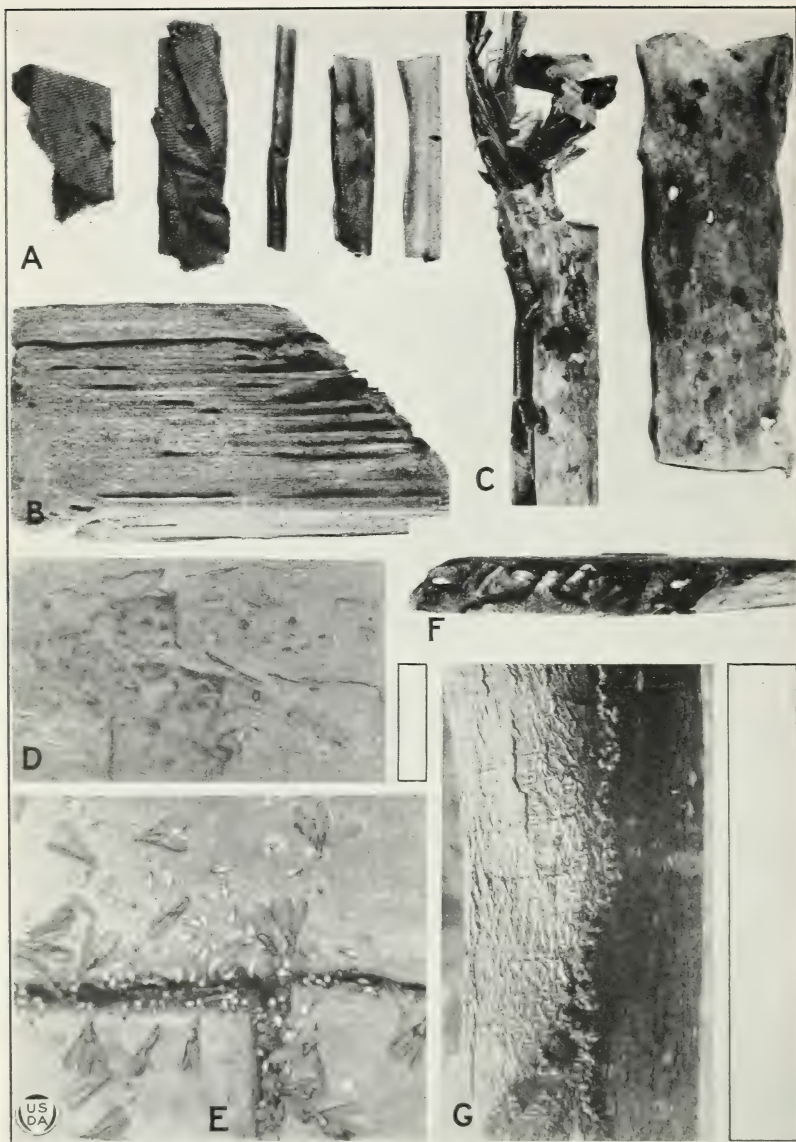
INJURY TO LEAD-COVERED CABLE BY THE TERMITE *COPTOTERMES NIGER* AT MIRAFLORES LOCKS, C. Z.

In the long service tunnel, in the center wall, some of the cables run in the space between the ceiling and walls—i. e., a niche was provided for this purpose. Small creosoted (dipped) blocks of wood had been put at regular intervals as wedges to prevent these cables from falling out. Plenty of termite galleries were found in this big tunnel, and in many instances these insects had gone to and were found in these creosoted blocks and did not seem to be repelled by the creosote. The termites had also damaged untreated oak and the native hard "bullet wood" braces.

In one case the termite gallery left one conduit pipe and was continued into space, forming a loop which found no attachment until it reached the lowest point in the next conduit below, and then started to make another loop. (Pl. V. A.) The direction was downward. In the tunnel, where one surface is perpendicular to another, cases were observed where the termites on reaching the next wall continued their tunnel into space; such cases were common, but always appeared to be abnormal and due to the conditions encountered. Such galleries were usually branched, as if the termites were trying to locate a surface for attachment.

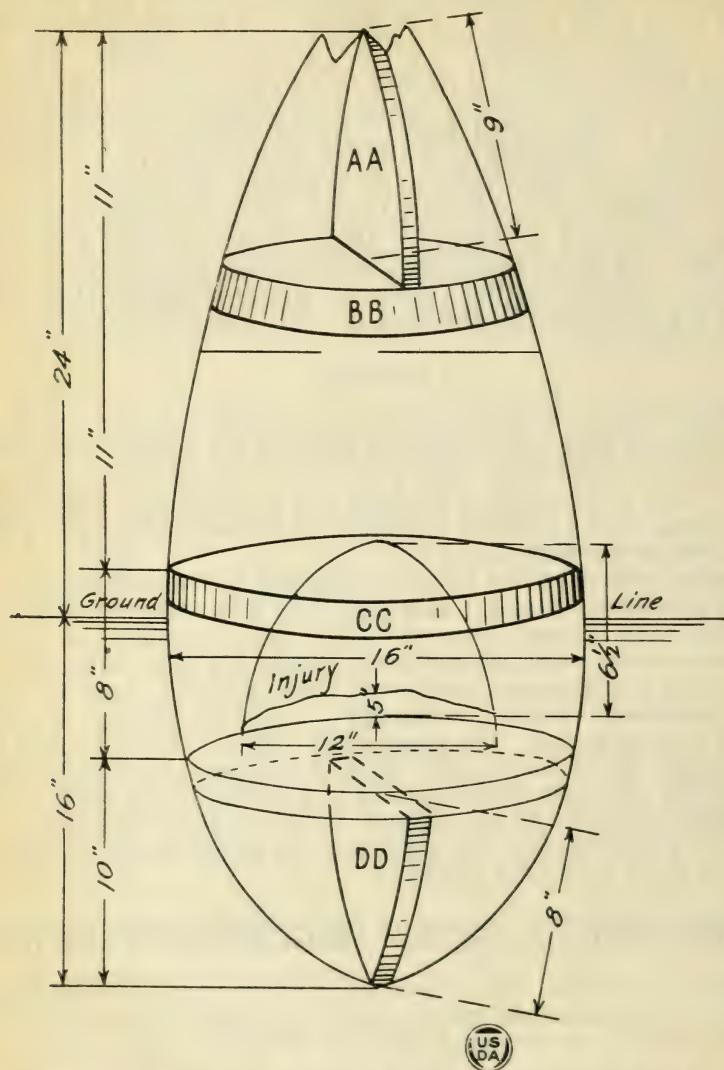
FIG. 1.—Diagram to show general shape and size of trunk of coconut palm shown in Plate VII, its relation to ground level, and location of four sections that were cut and photographed. Location of injury through which termites entered is also shown.

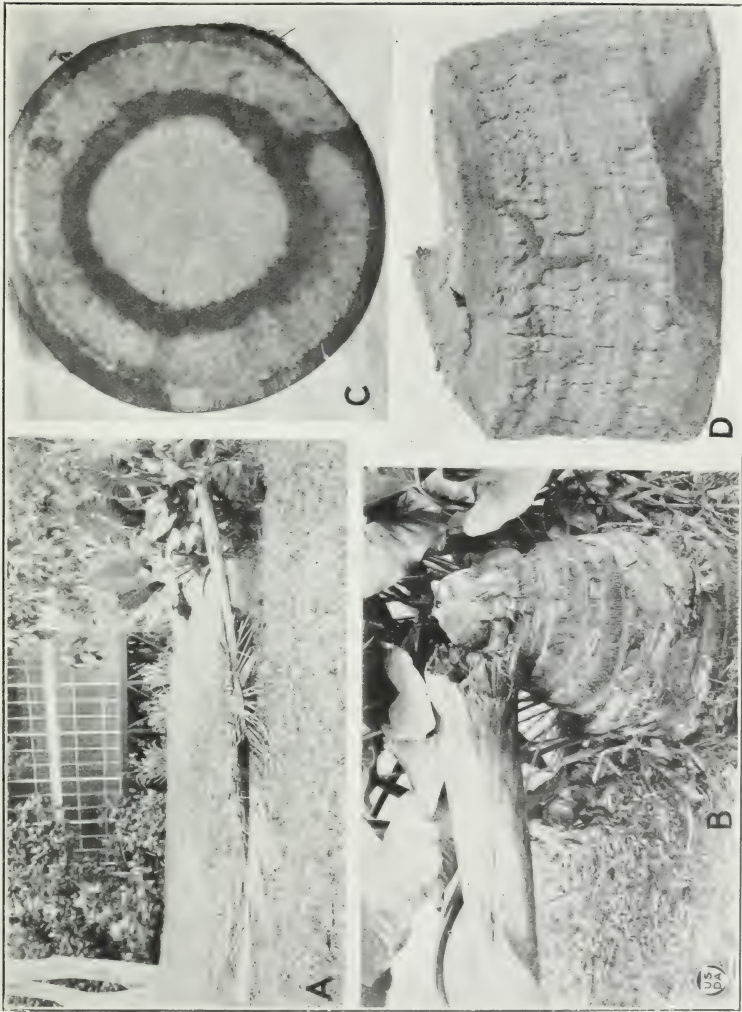
The photographs show the palm after it had fallen. The close-up of the trunk (Pl. VII, *B*) shows at the base a slanting injury. The extent of this wound is better shown in the accompanying sketch (fig. 1), which gives the size and shape of the trunk, relation to ground level, and the location, size, and shape of the wound. This wound is of importance because it afforded entrance to termites. During the time the palm was being watched this wound was suspected of harboring termites, but there were no outward indications of their presence, and to have cut into the injury in search of them would have interfered with the experiment. There were no galleries up the palm trunk, but, as was discovered later, termites were present inside, having come up through the earth.

The termites were very abundant inside of the trunk, where they had formed a well-defined termitarium. Only soldiers and workers were present, however, and there were no signs of queen chambers. Five photographs were taken of a section through this termitarium which illustrate well its character (Pls. VII and VIII). Special attention is called to the runways in the shape of holes (Pl. VIII, *B*, *C*, *D*, *E*). At the widest part of the termitarium the termites filled about one-third the width of the trunk, or about 6 inches, but their tubular runways went to all parts, although none were seen as far up as *BB* of the sketch (fig. 1).

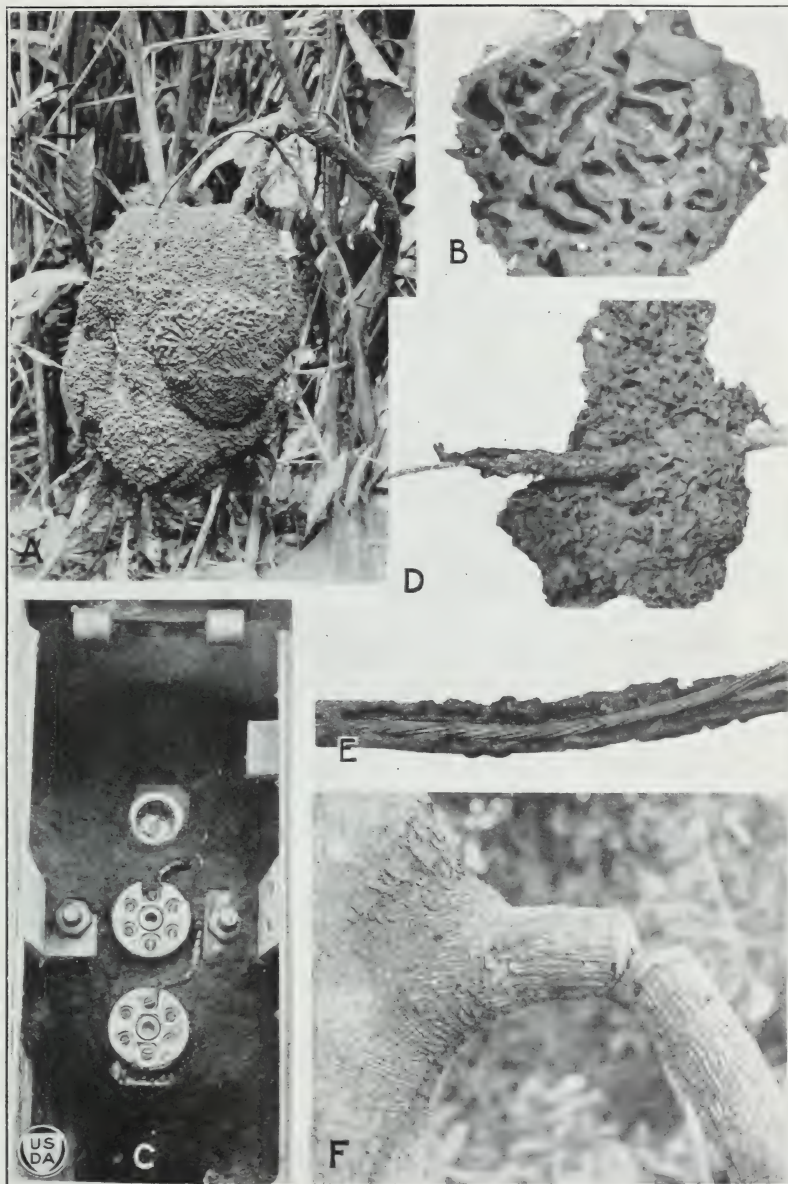
DAMAGE TO LEAD-COVERED CABLES BY THE TERMITE *COPTOTERMES NIGER*.

A, Tape, rubber, and paper insulation perforated; near Cristobal. *B*, *F*, Damage to wood form under concrete wall cover to tunnel through which cables run at Miraflores Locks. *C*, Damage to lead cable and insulation on this tunnel. *D*, Galleries of *C. niger* in trunk of coconut palm at Ancon, C. Z. *E*, Swarm of colonizing sexual adults of *C. niger*, showing workers and soldiers; from central wall, central tower, Miraflores Locks. *G*, Shelter tubes of *C. niger* on avocado tree at Frijoles, C. Z.

Specimens of the termites inside of the lead-covered cable were collected as well as those in the wood. Specimens of the infested wood, of the damaged cable, and of damaged insulation (Pl. VI, B, C, F) were collected. All of this damage was caused by *Coptotermes niger*.

This injury to lead-sheathed cables is what might be termed a "local" damage. Such cases are not at all infrequent and occurred also at Pedro Miguel and Gatun. If all the wood had been removed at the proper time, however, there would have been none of this damage.
